# TxDOT PT/Grout Issues

Brian D. Merrill, P.E.  
State Bridge Construction &  
Maintenance Engineer

# PT/Grouting Issues

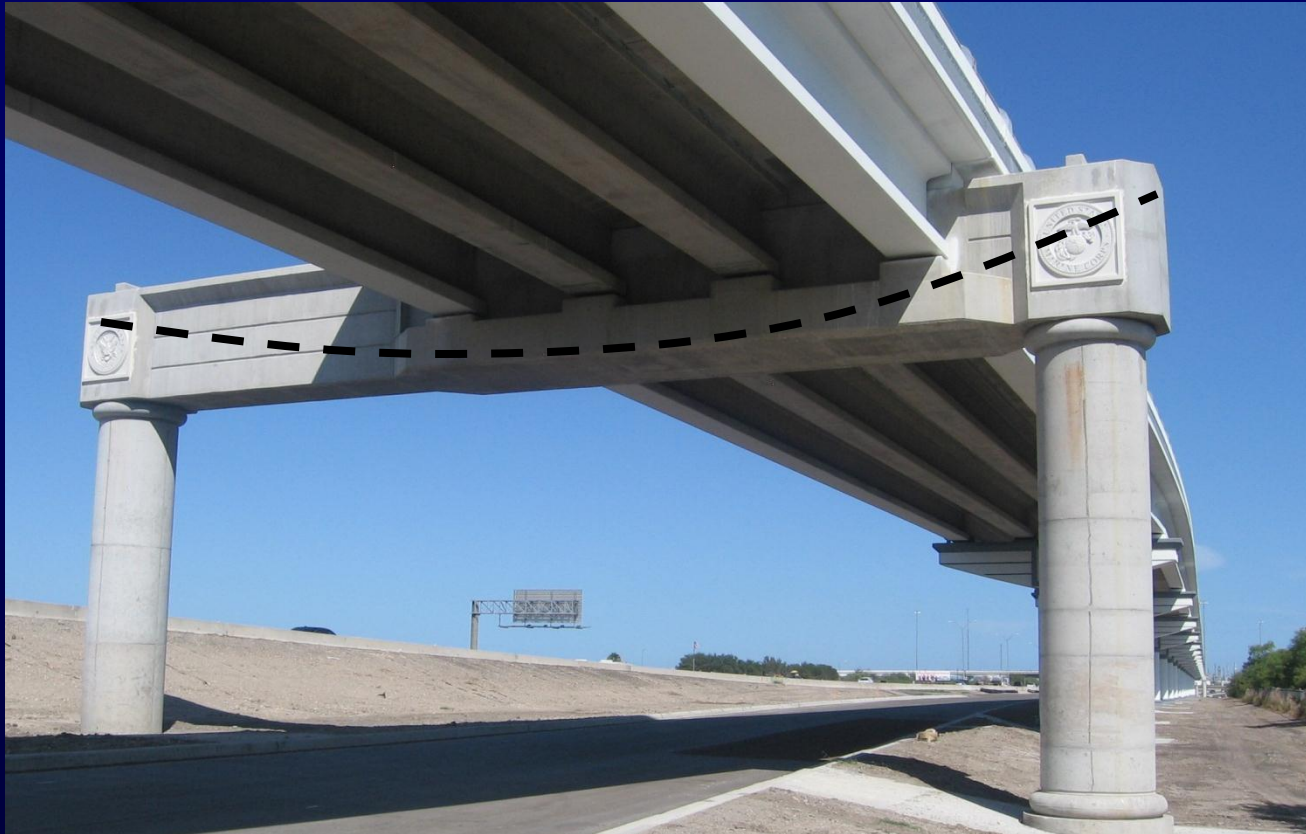
5 bents, 5 tendons per bent , 14-19 strands per tendon

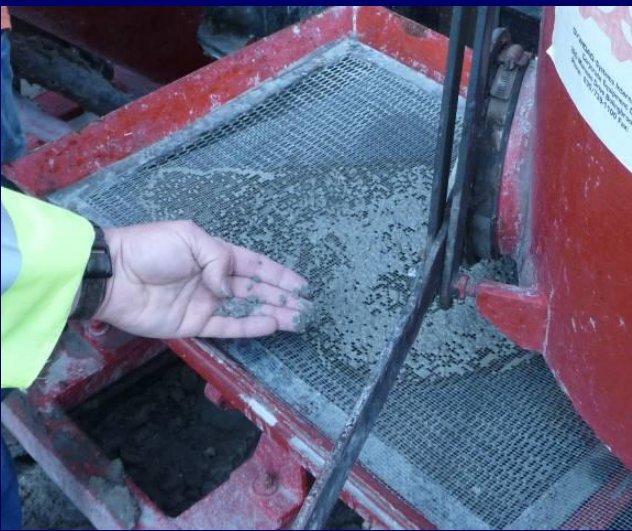
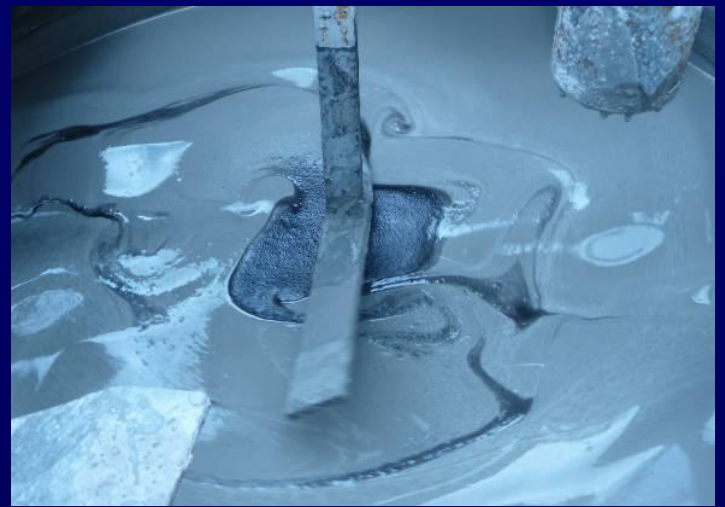
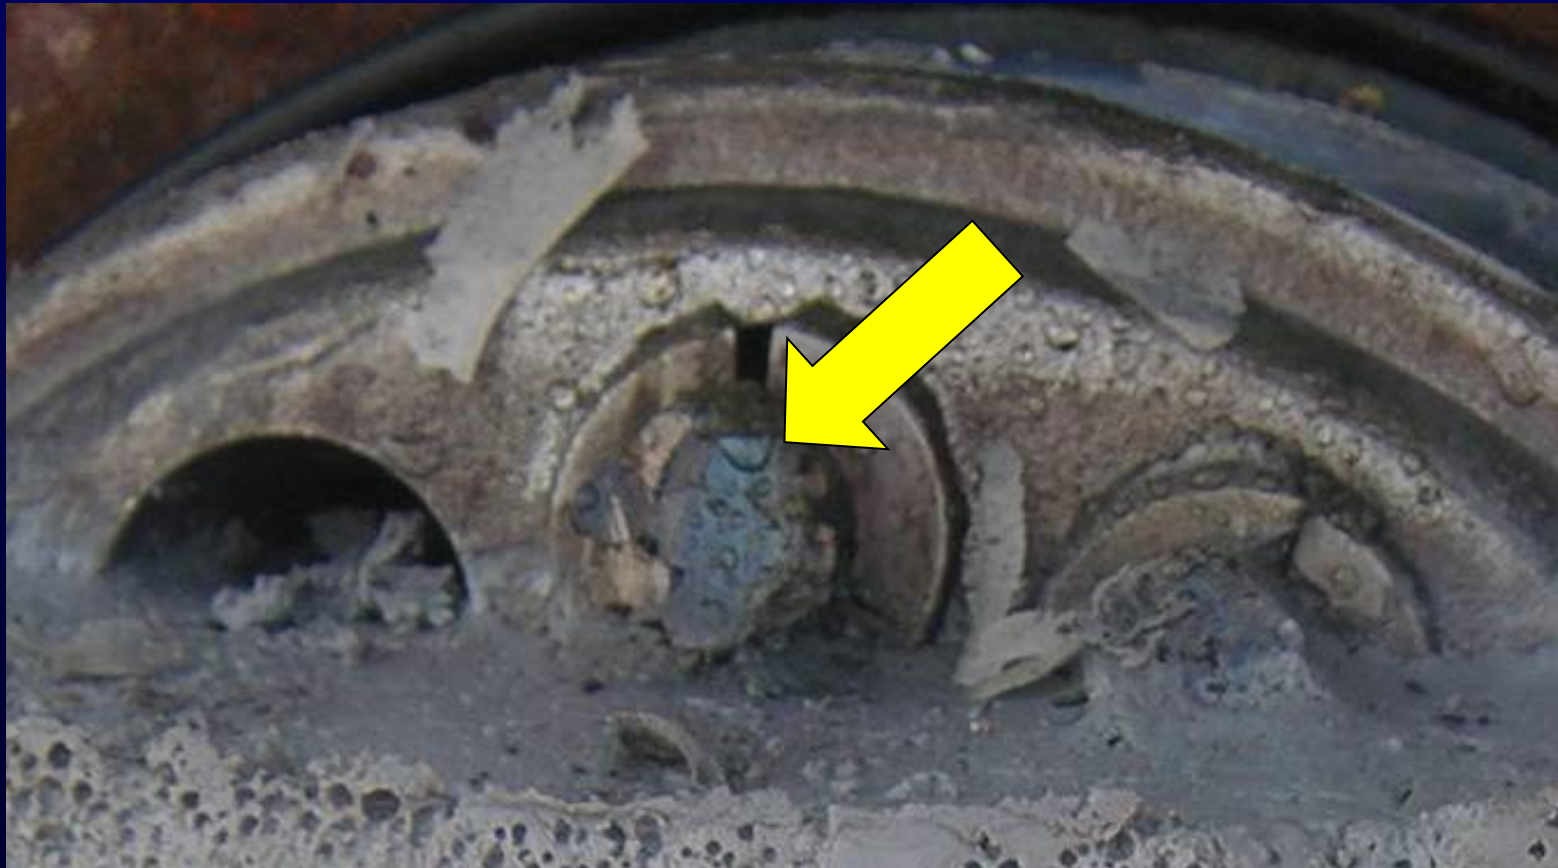
- Grout storage
  - Too long (up to 9 months, past shelf life)
  - Too hot ( $>120^{\circ}\text{F}$ )
- Mixing/pumping issues
- Several blow-outs reported
- Inconsistent procedures
- “burping” tendons
- Pumping pressure/speed

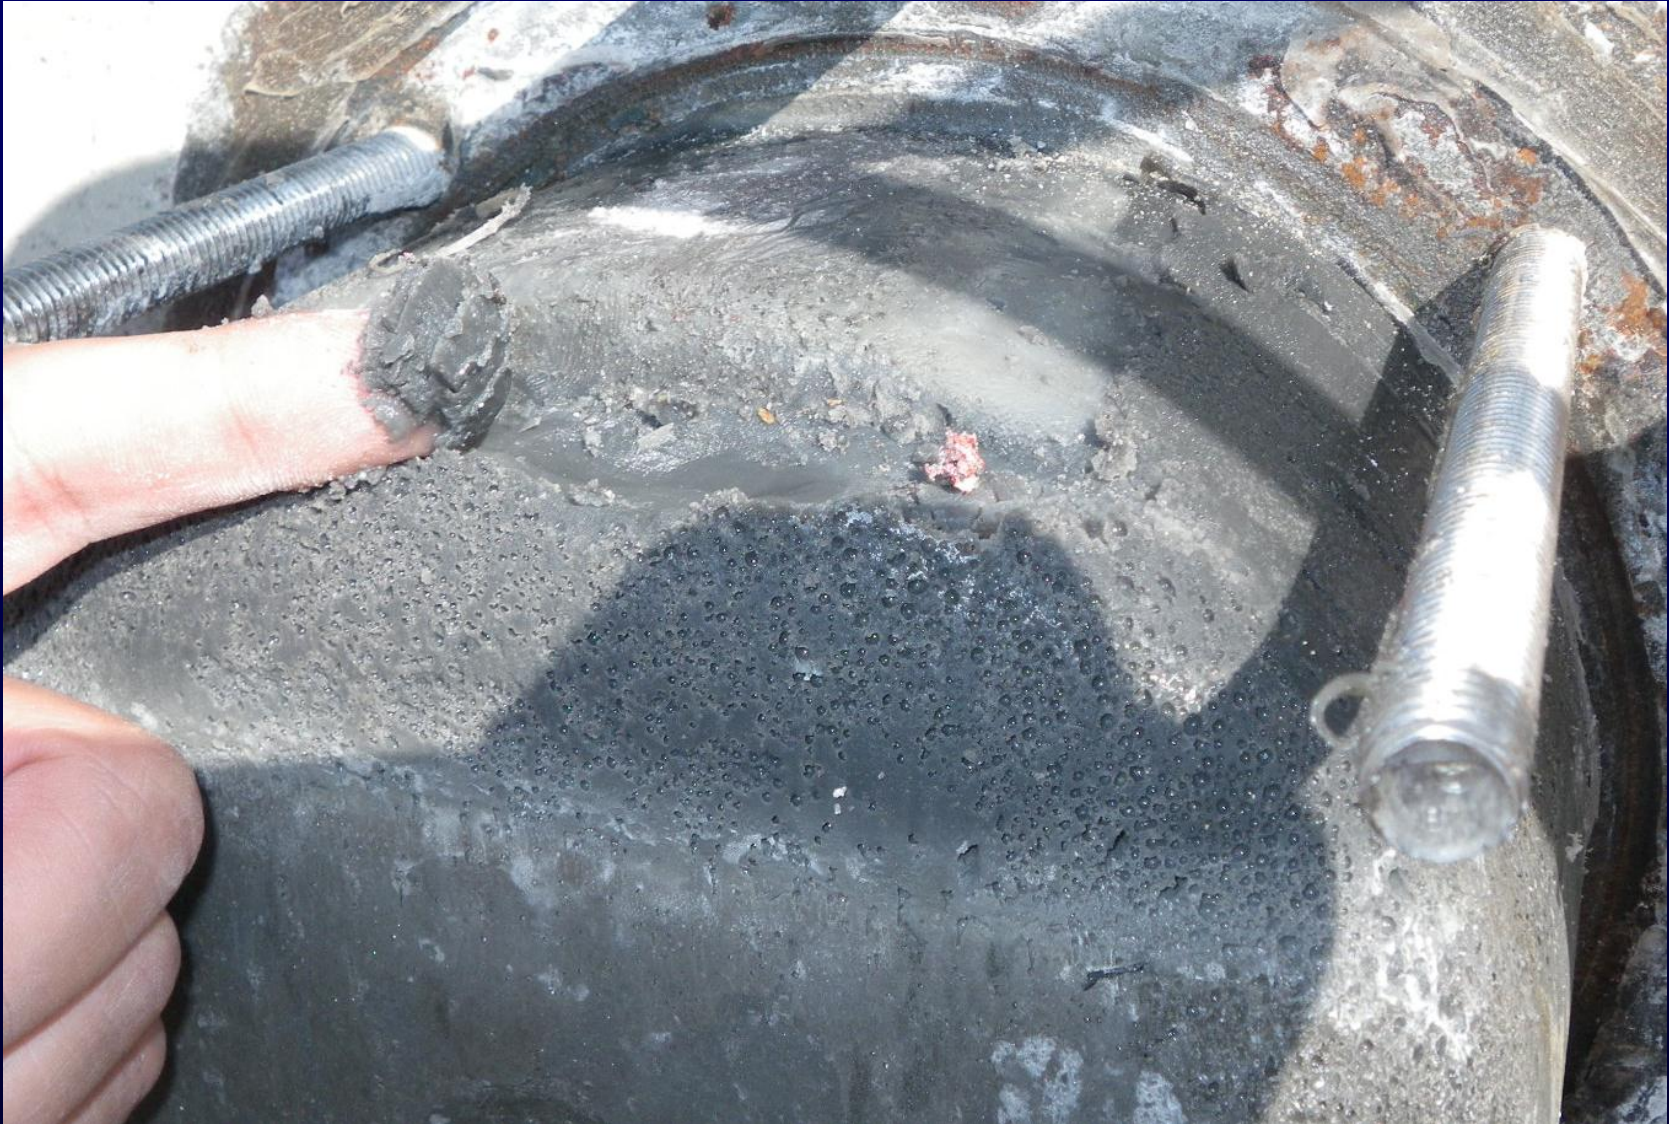
# Grout Segregation w/o Chlorides

- Diff grout mnfr/grouter
- “gelatinous” grout in top portion
- Segregated
- High concentrations of Na, K, S
- Confined to cap region – did not extend into ducts

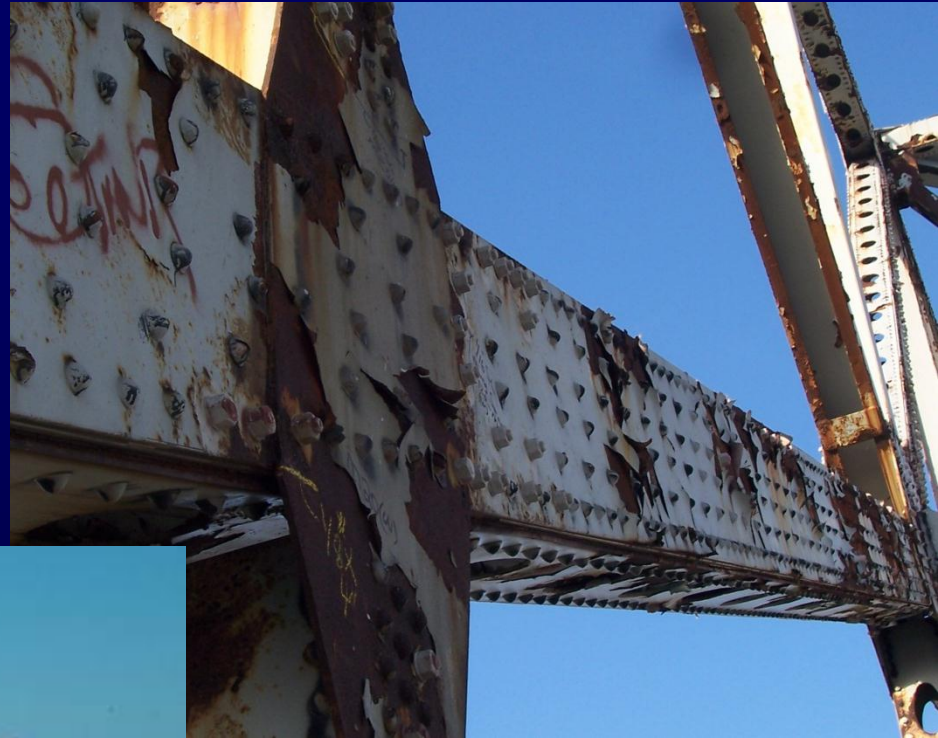
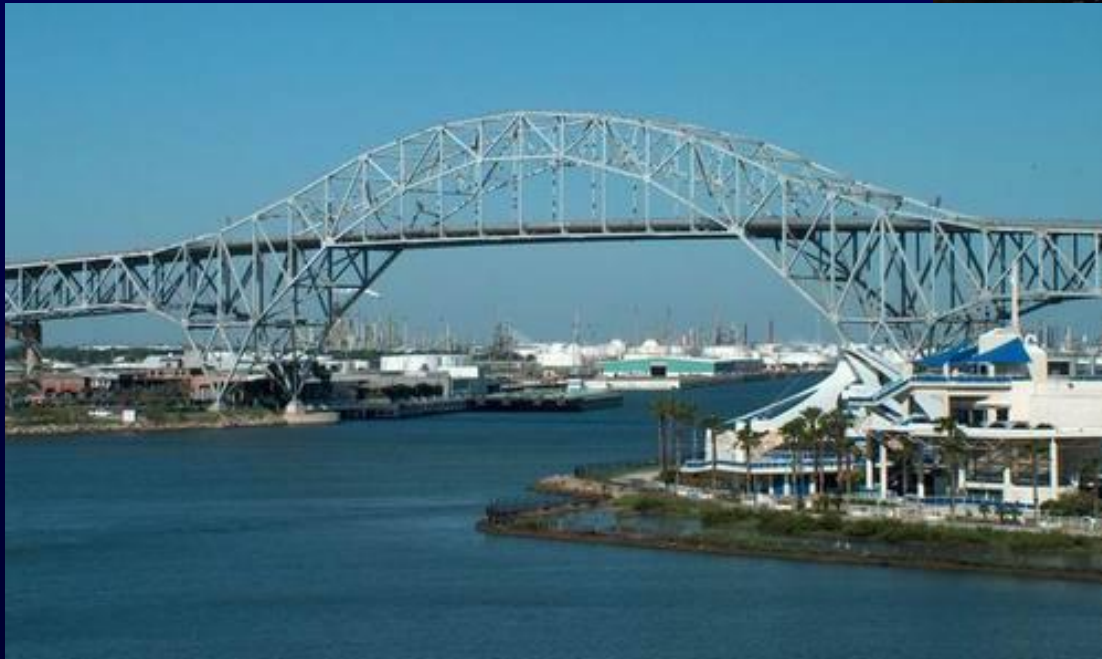
52 years old  
\$9M in 1959  
\$50+M maintenance costs  
Will be replaced with  
segmental bridge ~ 2020
